St Ambrose Memorial Church

State Heritage Register No. 01853

Statement of Heritage Impact for Underpinning and Reinstatement of Flooring

Date – 8 Oct 2024

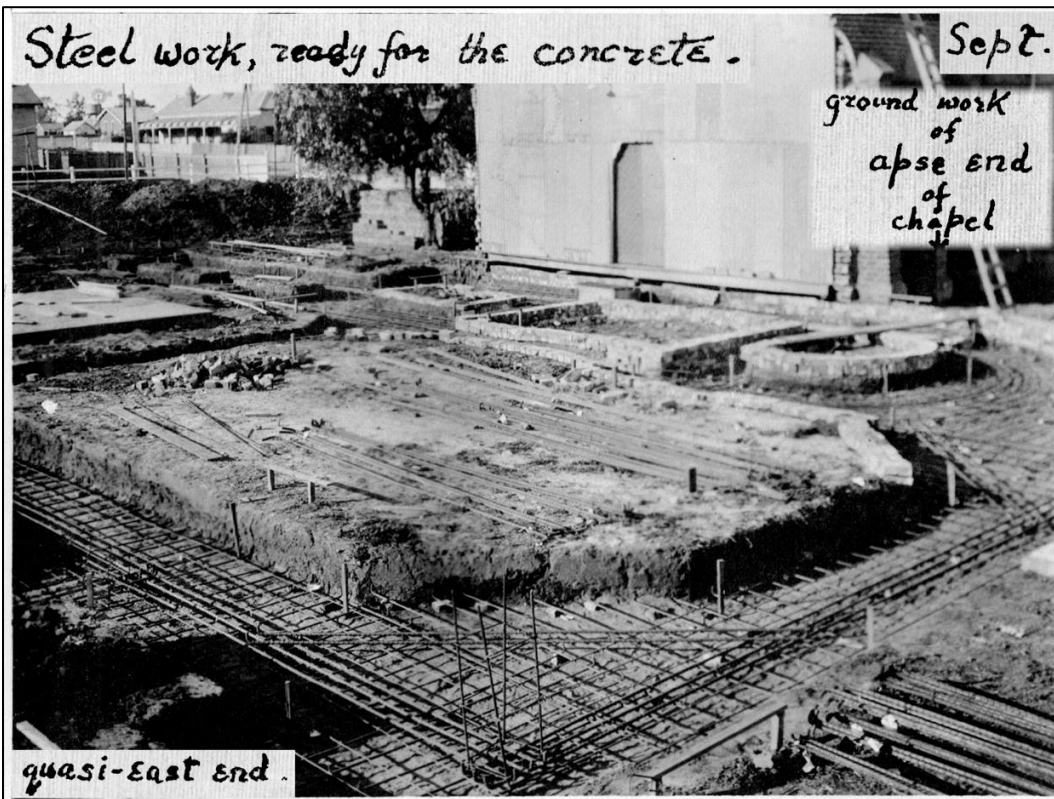
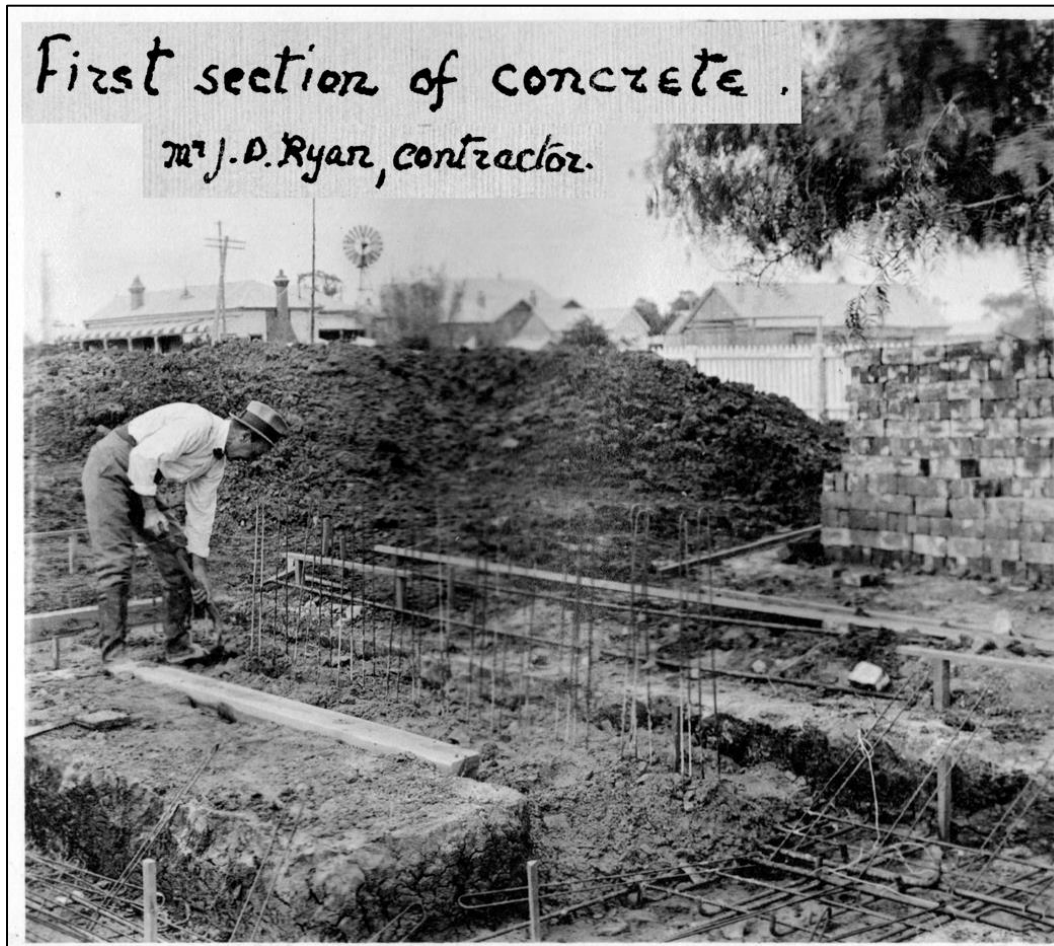
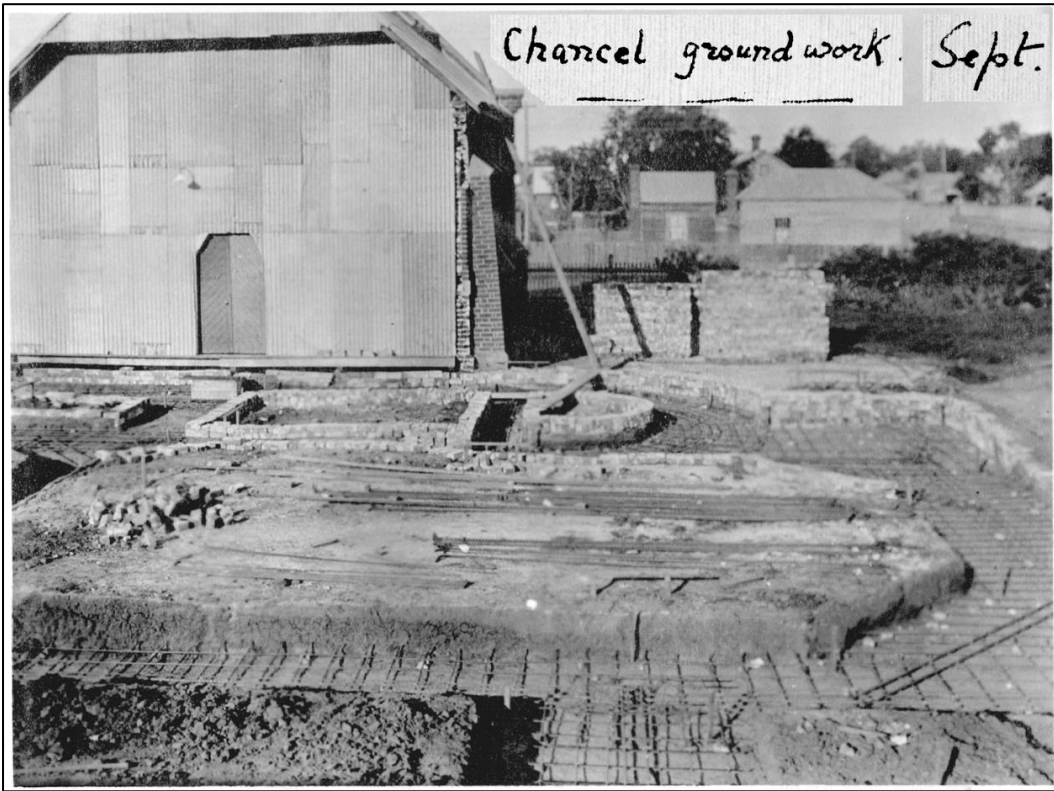
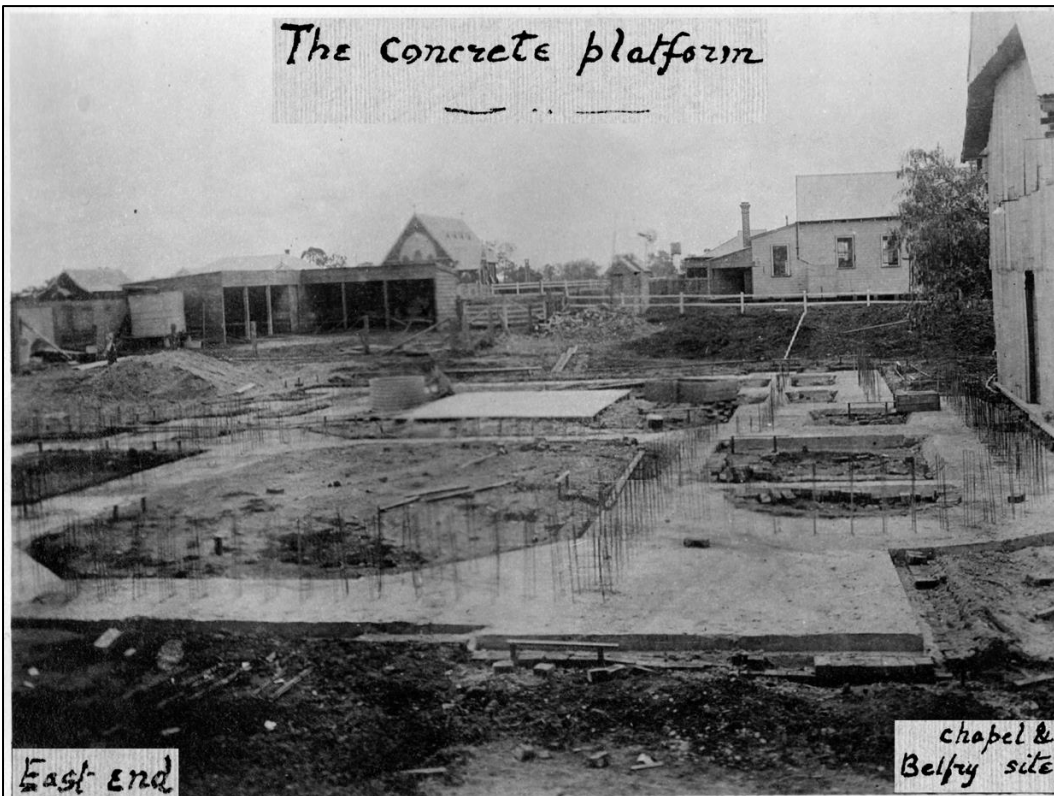
Of relevance to this proposal for underpinning, Geotechnical soil testing was unknown in the 1920s and the architect designed footings were shallow and insufficient for the highly reactive soil of this site. The following archival photographs show the shallow reinforced concrete footings constructed in the 1920s:

Figure 4: St Ambrose archival photographs showing the shallow, reinforced concrete footings constructed in the 1920s (Source: St Ambrose archives)

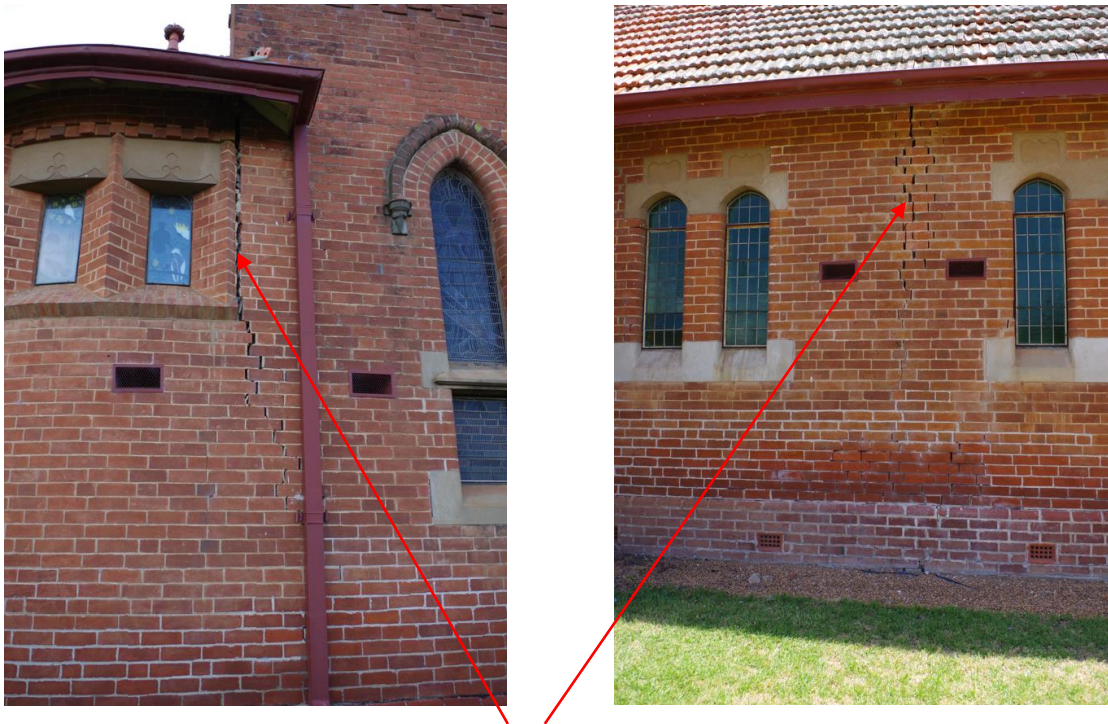
Figures 16 & 17: Substantial cracking to eastern wall of church. (Source: Michael Scott, Feb 23)

As the brick church has moved and continues to move enough to cause substantial cracking to the brick walls, to the extent that the church is not considered safe to occupy, immediate repairs are clearly required.

Before the brick walls can be repaired, the building needs to be stabilised, to minimise future movement and potentially, catastrophic damage. Our structural engineer, Bligh Tanner (BT) advised that underpinning is essential, so four soil boreholes were drilled – one near each corner of the church, by local Engineers - Barnson, to provide geotechnical information to inform the underpinning design by BT. The highly reactive soil the church is founded on is so deep, that concrete underpinning piers were designed to be 450mm diameter and 6.8m deep in some locations.

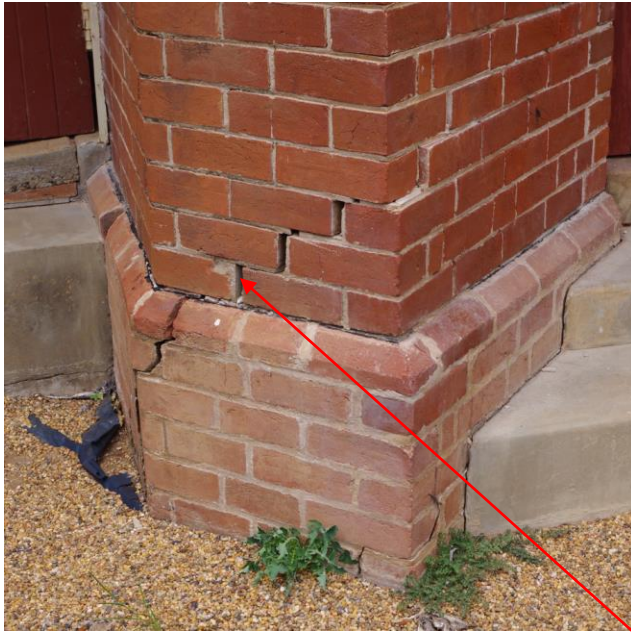
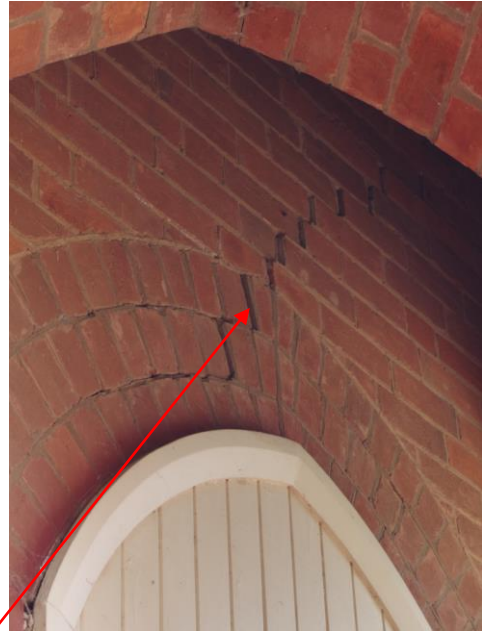
Figures 18 & 19: Substantial cracking to western and southern walls of church. (Source: Michael Scott)

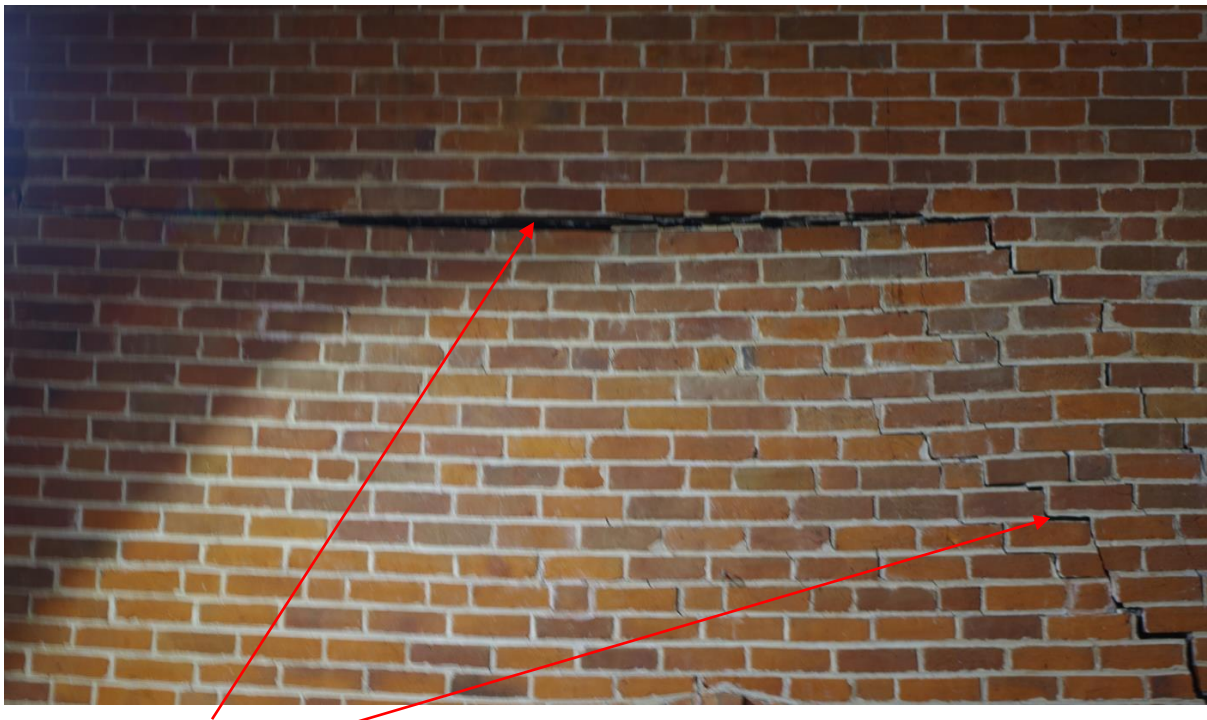
Figure 20: Substantial cracking to internal brick wall above Chapel arch. (Source: Michael Scott, Feb 23)

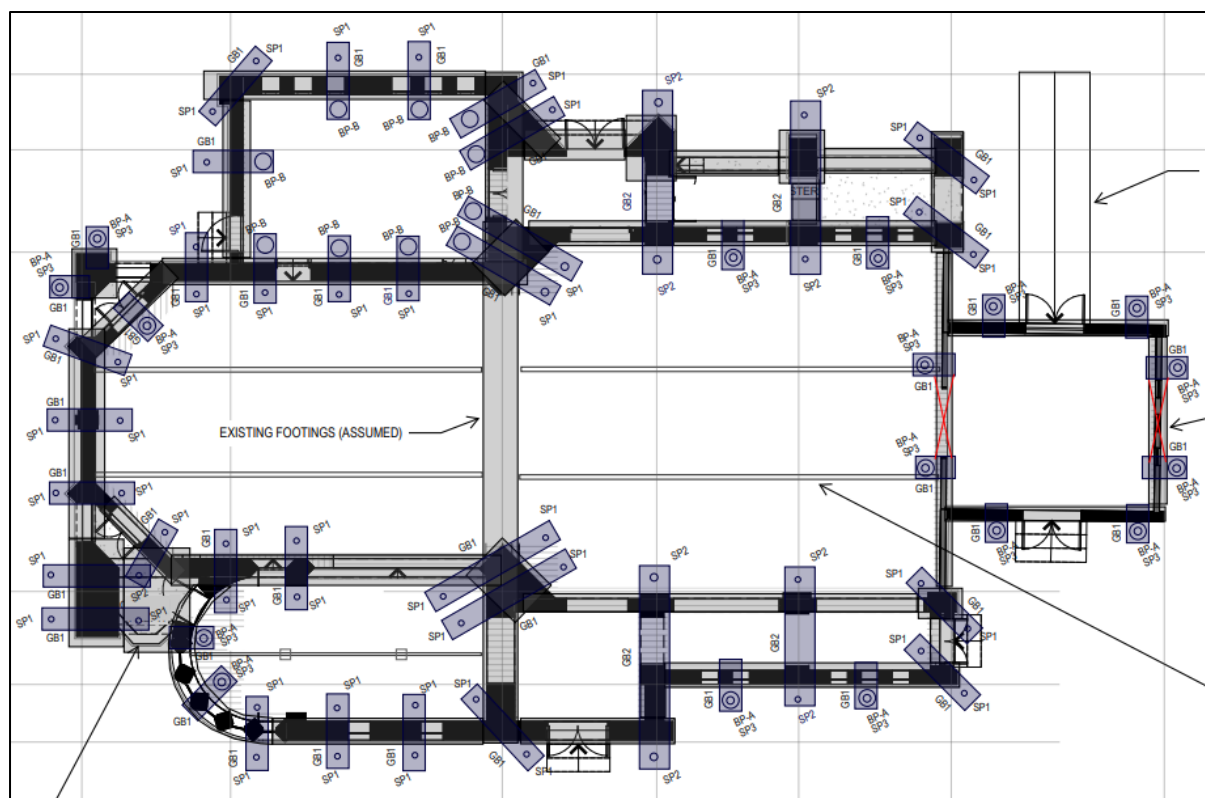
Figure 23: Foundation Plan showing piers (circles) and ground beams (rectangles) to support existing footings. (Source BT)

As the soil supporting St Ambrose is so highly reactive, 84 piers, up to 9m deep and 51 ground beams are required to adequately support this fragile and heavy brick building, as shown above. The structural engineer and preferred underpinning contractor Monteverde have met on site and confirmed the design shown above. Monteverde are very experienced underpinning contractors, with heritage experience, which gives us confidence the works can be successfully completed, with minimal ongoing movement to the church, once the work is completed.

The piers are a combination of screw piles and bored concrete piers, with screw piles used for preference, as they are cleaner and more economical than concrete. Bored concrete piers have been shown inside the Vestry, as there is not enough headroom to drill the screw piles into the ground in this location.

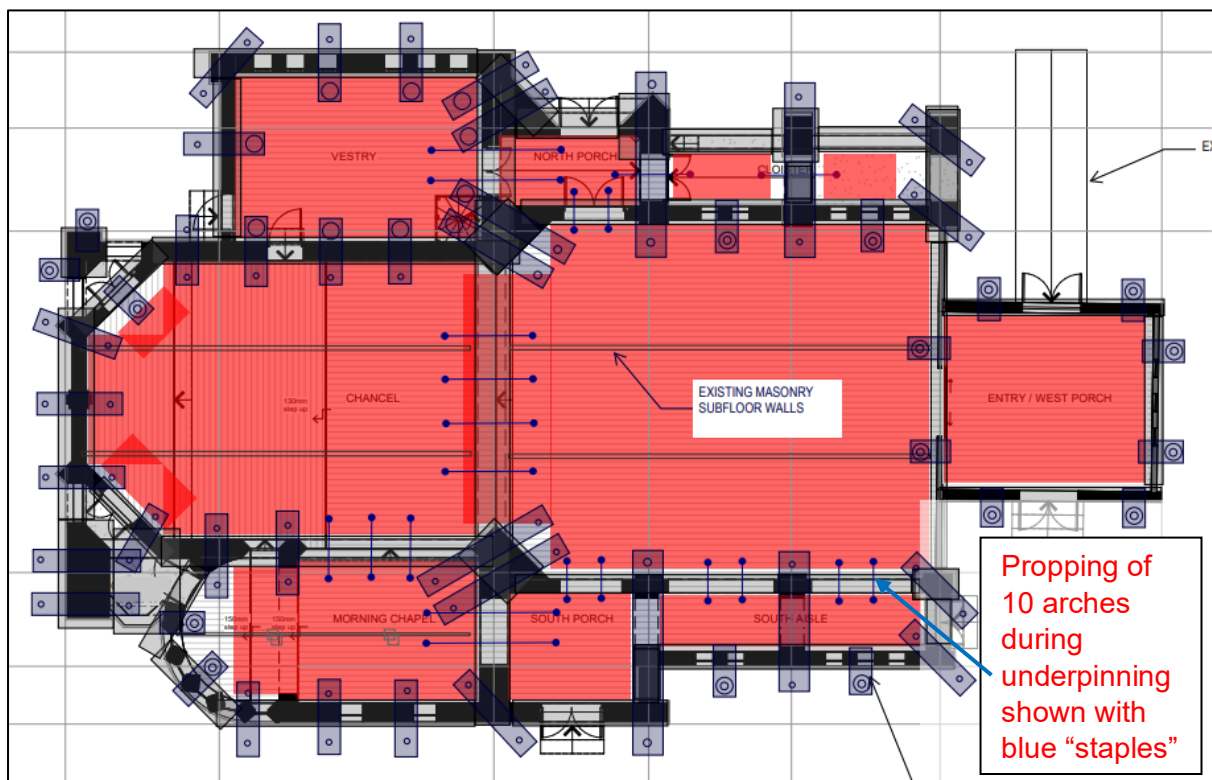
Figure 24: Early works plan - Existing floors to be removed to allow drilling of piers to interior of church. Note: North is to the right of this image. (Source: BT)

The external piers can be drilled without impact on the building, but to drill the internal piers the existing timber floors need to be removed and reinstated after the underpinning has been done. As well as the timber floors some other elements also have to be removed and later reinstated, as shown in the early works drawings below:

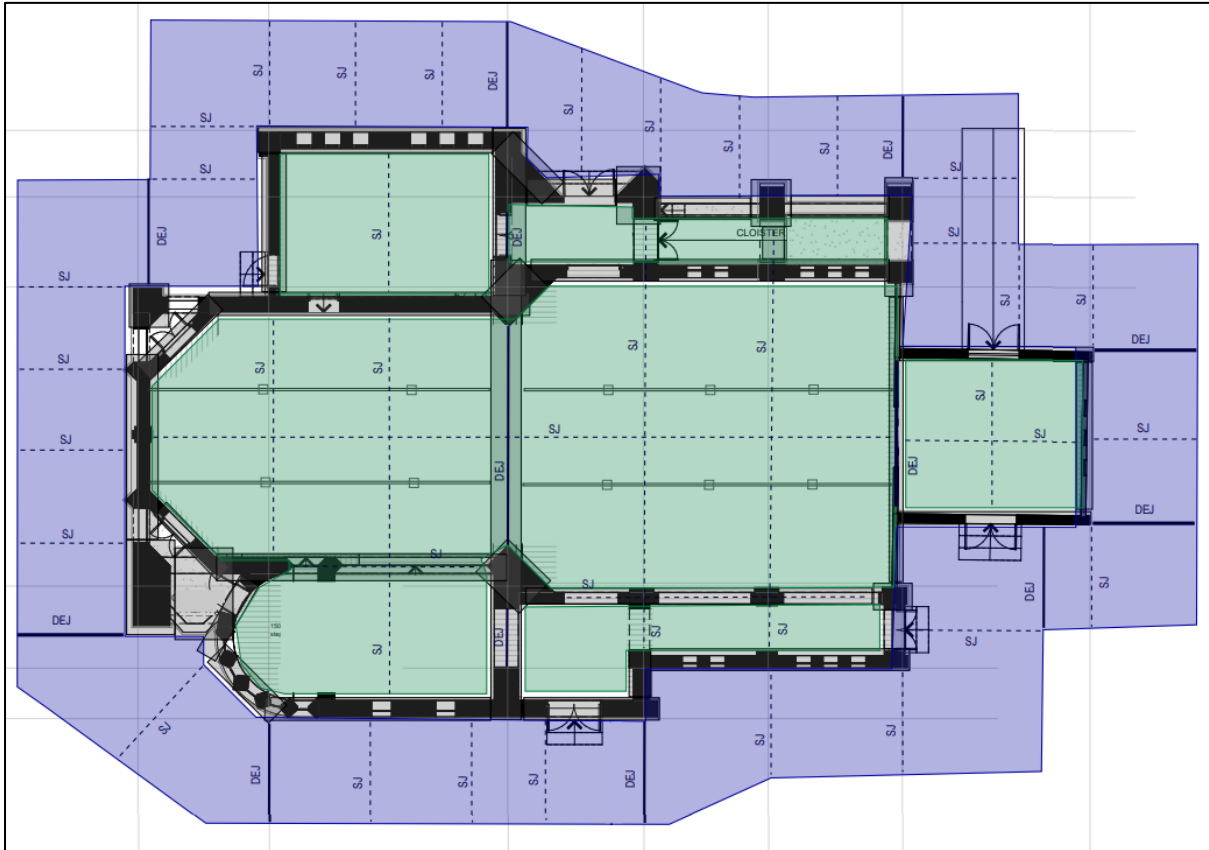
Figure 28: Apron slab around the exterior of the church (purple) is to be constructed to shed rain water and minimise future movement of the church.

The apron slab around the exterior of the church, is to be 100mm thick and 3m wide, cast on a taped polythene membrane with sawn joints and dowelled expansion joints as shown above. The reinstated timber floor is to be supported on galvanised SHS stumps with adjustable tops with or without a 75mm thick jointed slab cast on a taped polythene membrane (green in the plan above), above the concrete footings of the stumps. The cost/benefit assessment of the internal slab is still being decided by the project team. It is requested that the heritage application associated with this SOHI be approved with both options open, as a decision will be based on ensuring future movement of the church will be kept to a minimum.

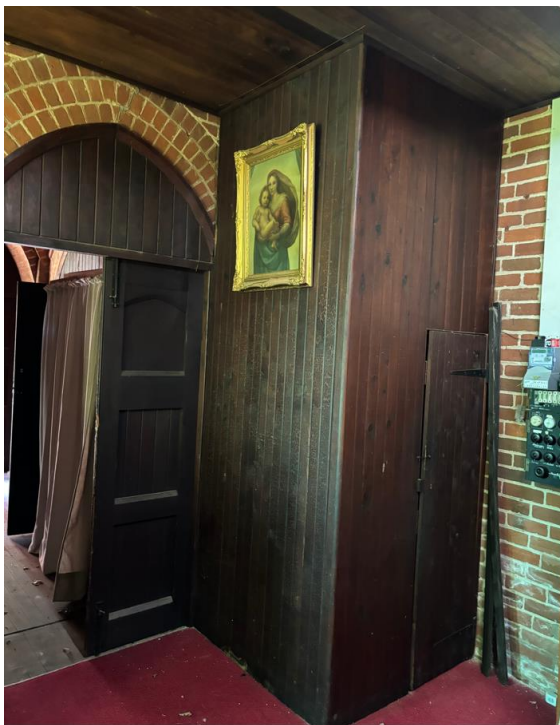
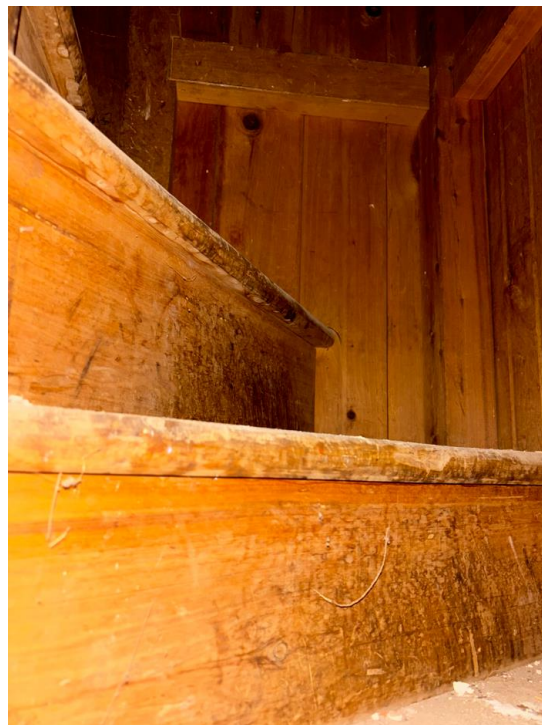
Figure 31: Spiral stair in Vestry to Loft above, enclosed within timber v.j. boards.

Figure 32: Detail of spiral stair inside timber Stair enclosure.

Remove timber spiral staircase to Loft above. Spiral stair is enclosed with timber v. jointed panels. Stair and enclosure to be stored on site, for re-erection when floors are re-instated

- The Anglican congregation is likely to replace existing carpeted areas with new carpet
- The spiral staircase with timber enclosure in the Vestry will be carefully removed and stored on site. It will be reinstated in its existing form and details

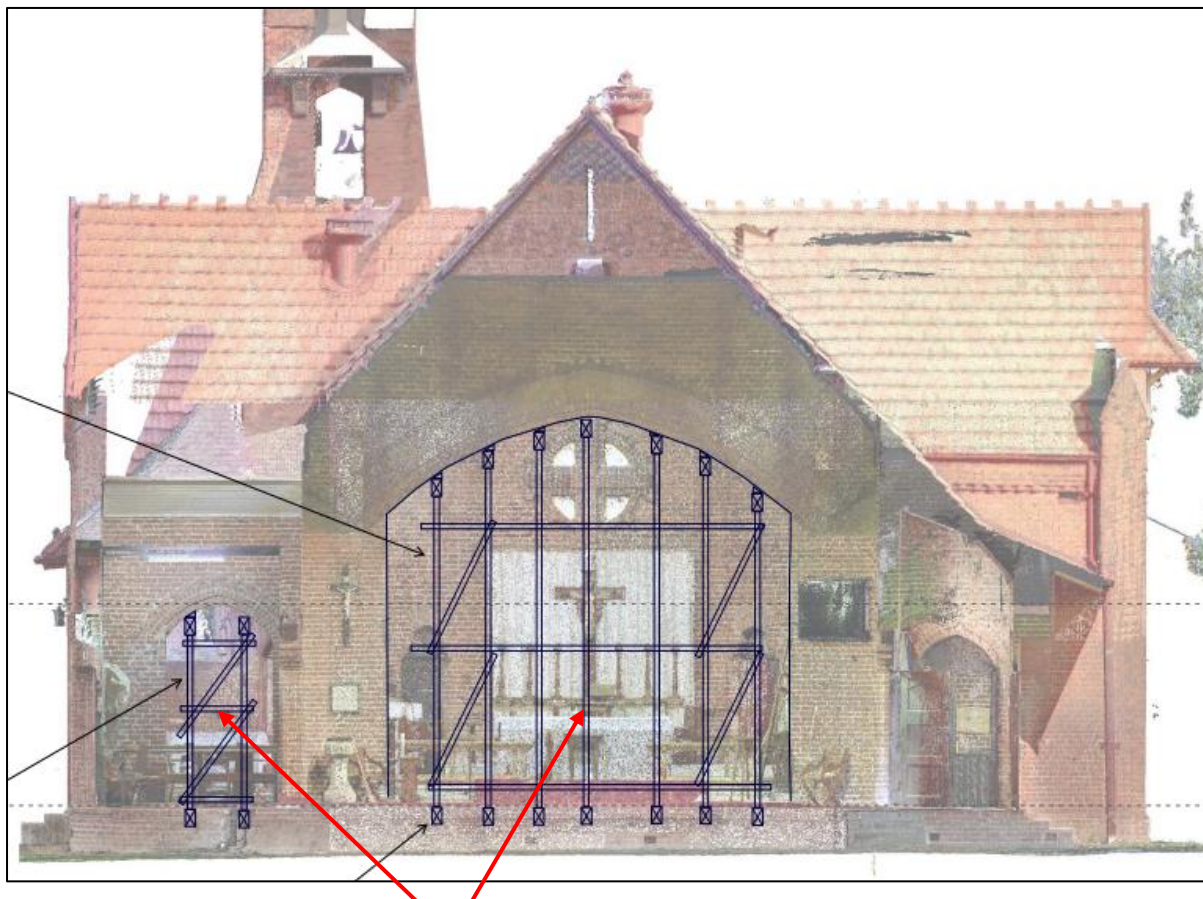
Figure 33: Temporary works – Indicative arch propping to support church superstructure while underpinning is constructed. (Source: BT)

See Figure ... for 10 brick arches within the church to be propped, while underpinning is being done. Our structural engineer has calculated loads for this propping to allow a local steel scaffolding contractor to quote for this work. The propping will need further discussion between the structural engineer and the scaffolding contractor to ensure the props are built to achieve suitable bearing capacity, including on the soil. The structural engineer has also noted that timber wedging at top of scaffolding is required to fit the supports tightly to the brickwork. The scaffolding will need to be erected, moved and disassembled progressively as the underpinning progresses, to ensure the church superstructure remains intact and undamaged by the underpinning.
