Preliminary contamination investigation

Lot 1 and part Lot 2 361 Oxley Highway, Gilgandra NSW

Summary report

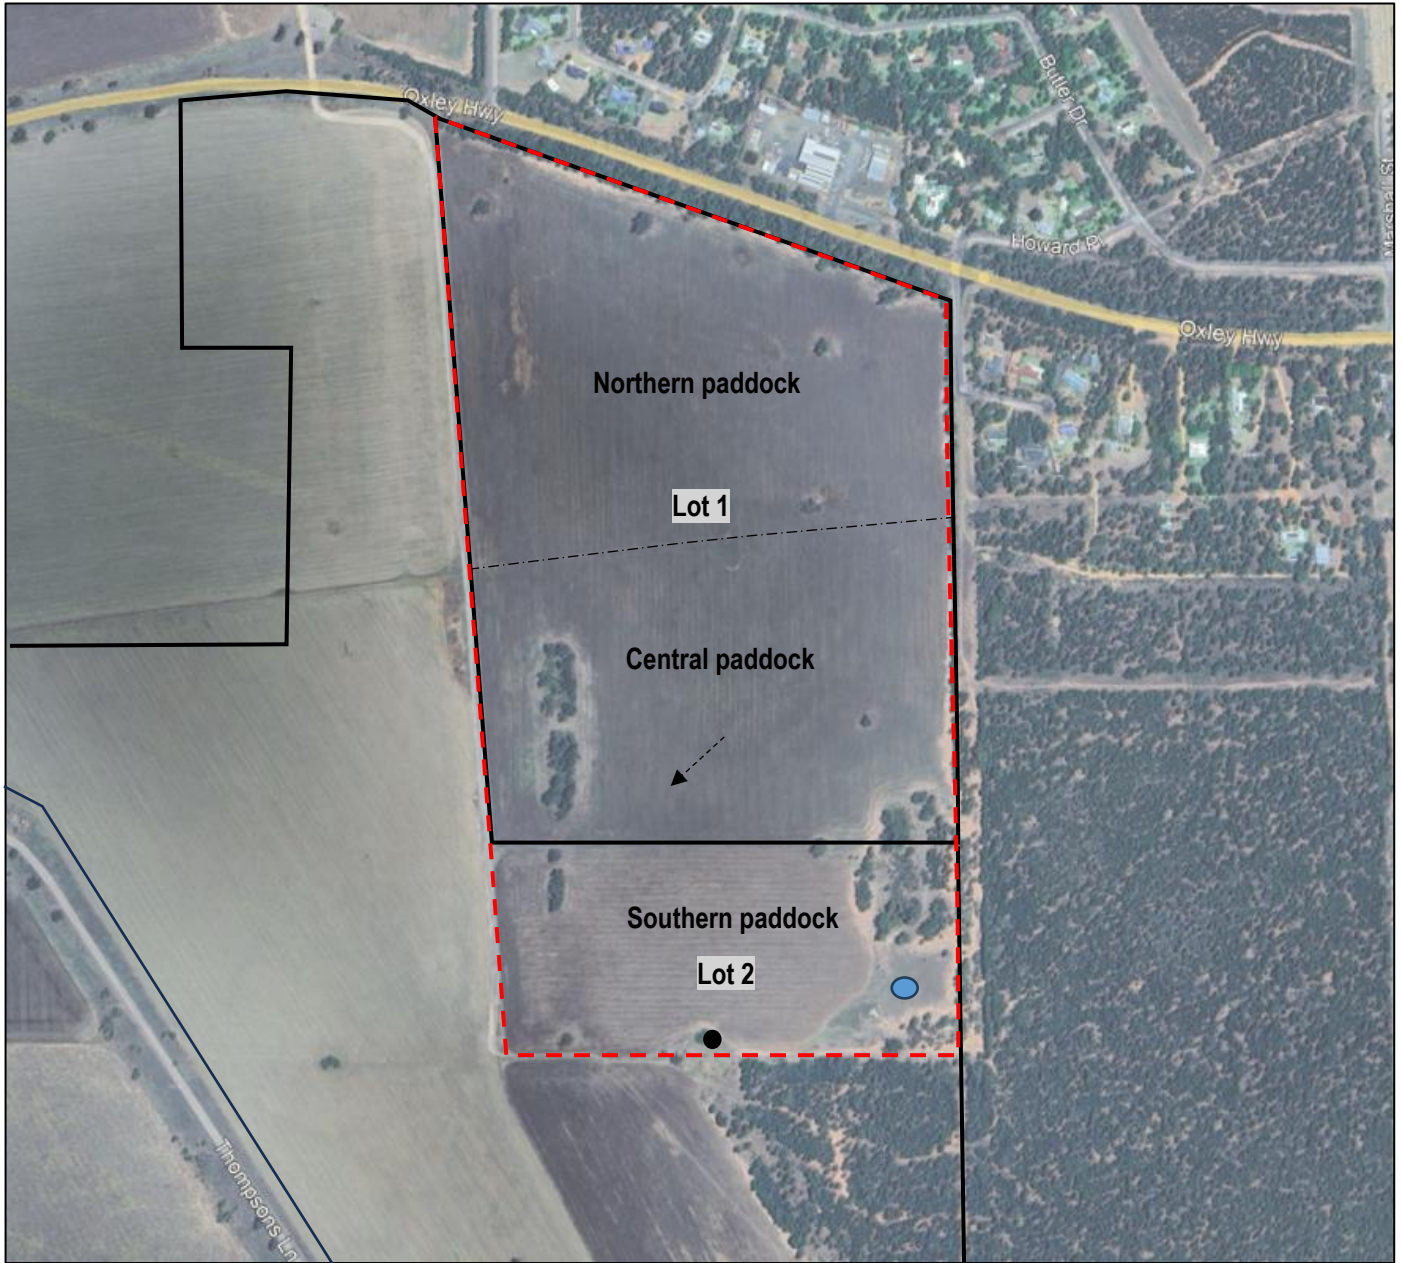
- - - Investigation area
- Dam (dry)
- Lot boundary
- Internal fence
- ↘ Slope
- Water tank ruins

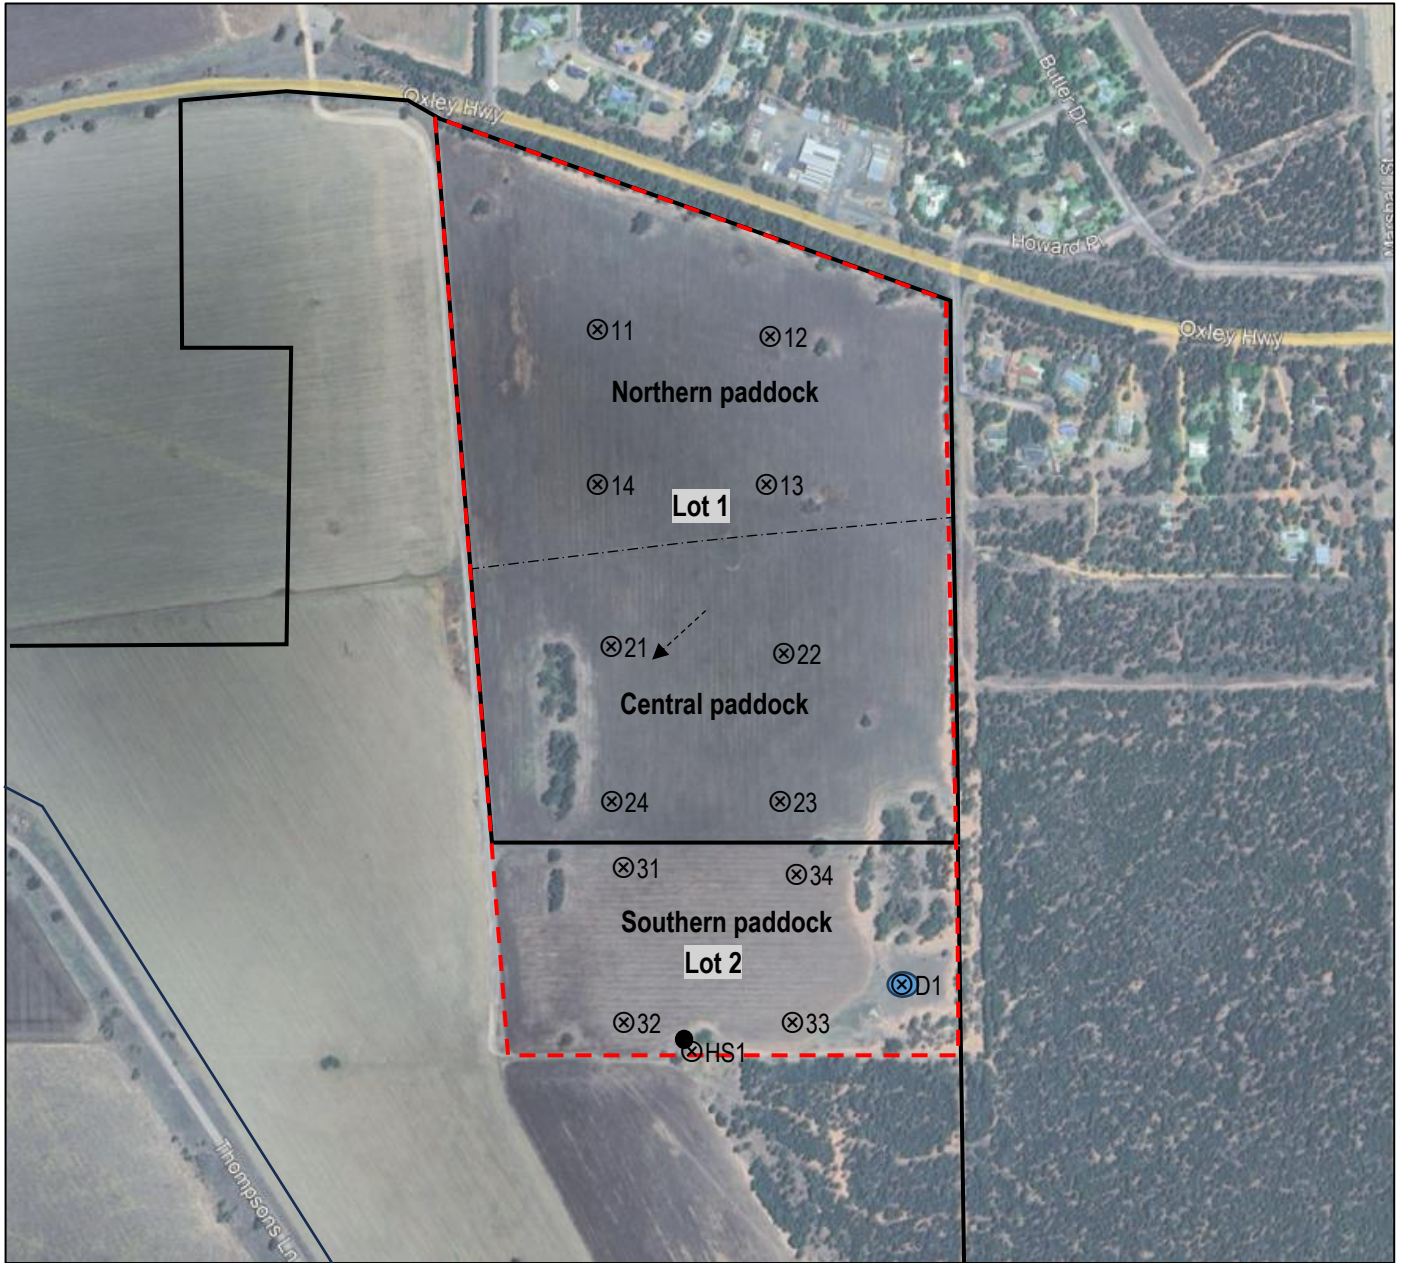
- - - Investigation area
- Lot boundary
- Internal fence
- Dam (dry)
- ↘ Slope
- Water tank ruins

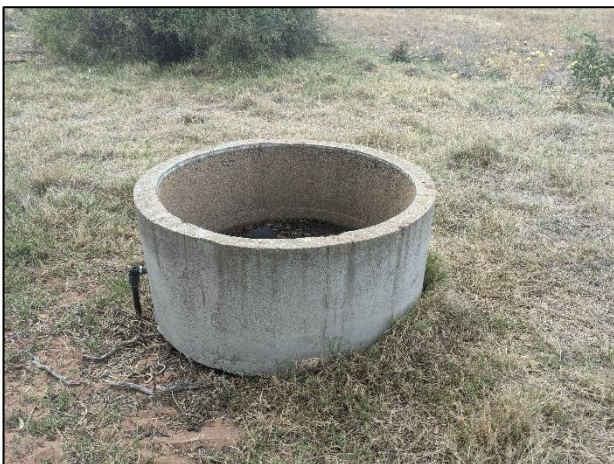
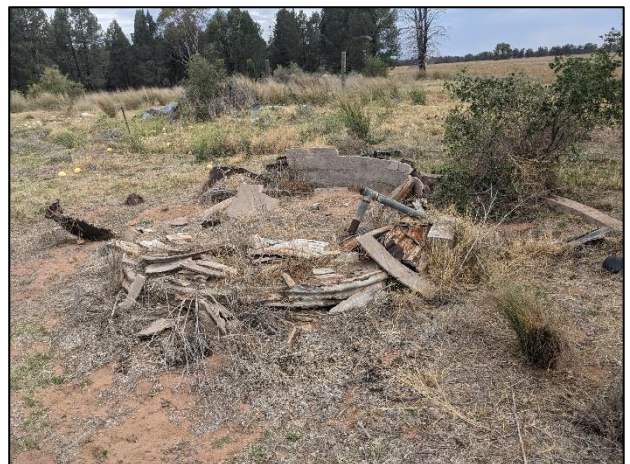
Ruins of a former water tank were identified on the southern section of the site. The foreign materials contained in the ruins represent an amenity hazard.

Water tank ruins

The site is suitable for commercial/industrial land-use. Foreign materials including the building materials from the former water tank located in the southern section of the site are considered an amenity hazard.

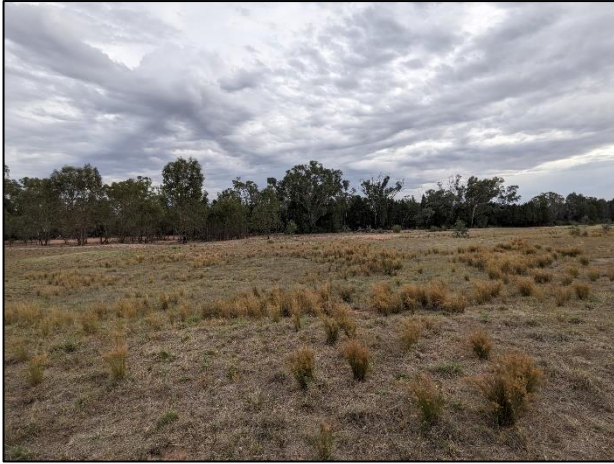
Surface water is expected to infiltrate in the sandy soils, discharge into the southern dam or flow south west to Marthaguy Creek located approximately 4km south west of the site. The dam was found to be dry at the day of the inspection.

Dam location (dry)
